Overview of the First Quarter 2020 Surveillance and Maintenance Report for the Rocky Flats Site, Colorado

January-March 2020

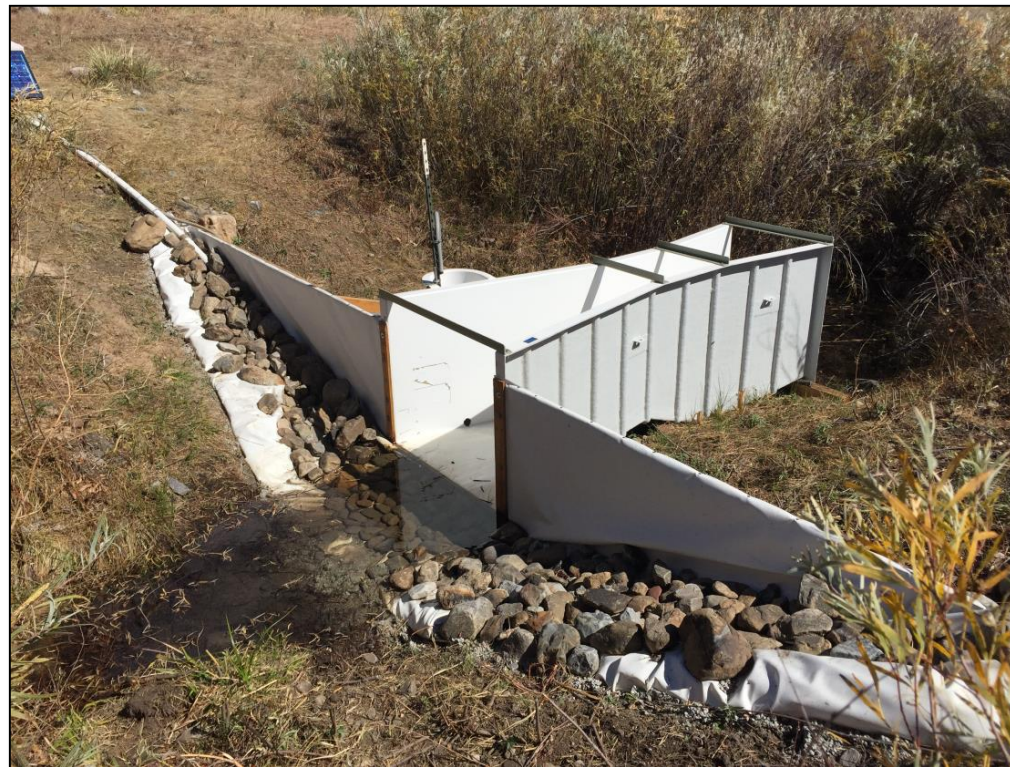
Original Landfill Performance Monitoring

- Original Landfill (OLF) – location GS59
 - Routine surface water sampling in Woman Creek, downstream of the OLF (GS59), during the first quarter of 2020 showed mean concentrations for all analytes below applicable RFLMA water quality standards

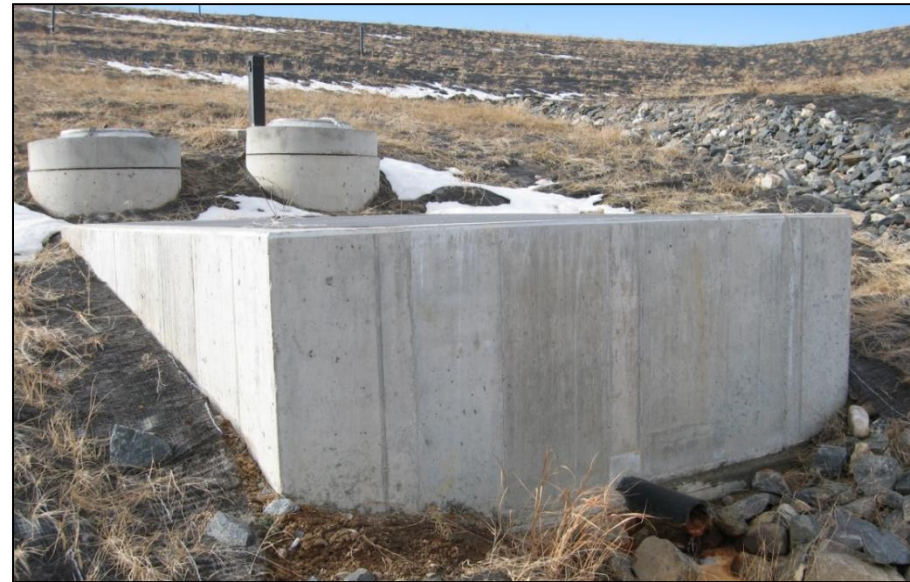
Present Landfill Performance Monitoring

- Present Landfill Treatment System (PLFTS) — location PLFSYSEFF
 - During the first quarter of 2020 at the system effluent, the arsenic concentration was 29 µg/L, exceeding the standard of 10 µg/L
 - According to RFLMA protocols, sampling frequency was increased to monthly
 - For the subsequent monthly sample, the arsenic concentration was 4.8 µg/L, below the 10 µg/L standard
 - After the subsequent monthly sample was evaluated, sampling frequency returned to quarterly
 - Quarterly concentrations for all other analytes were below applicable RFLMA standards

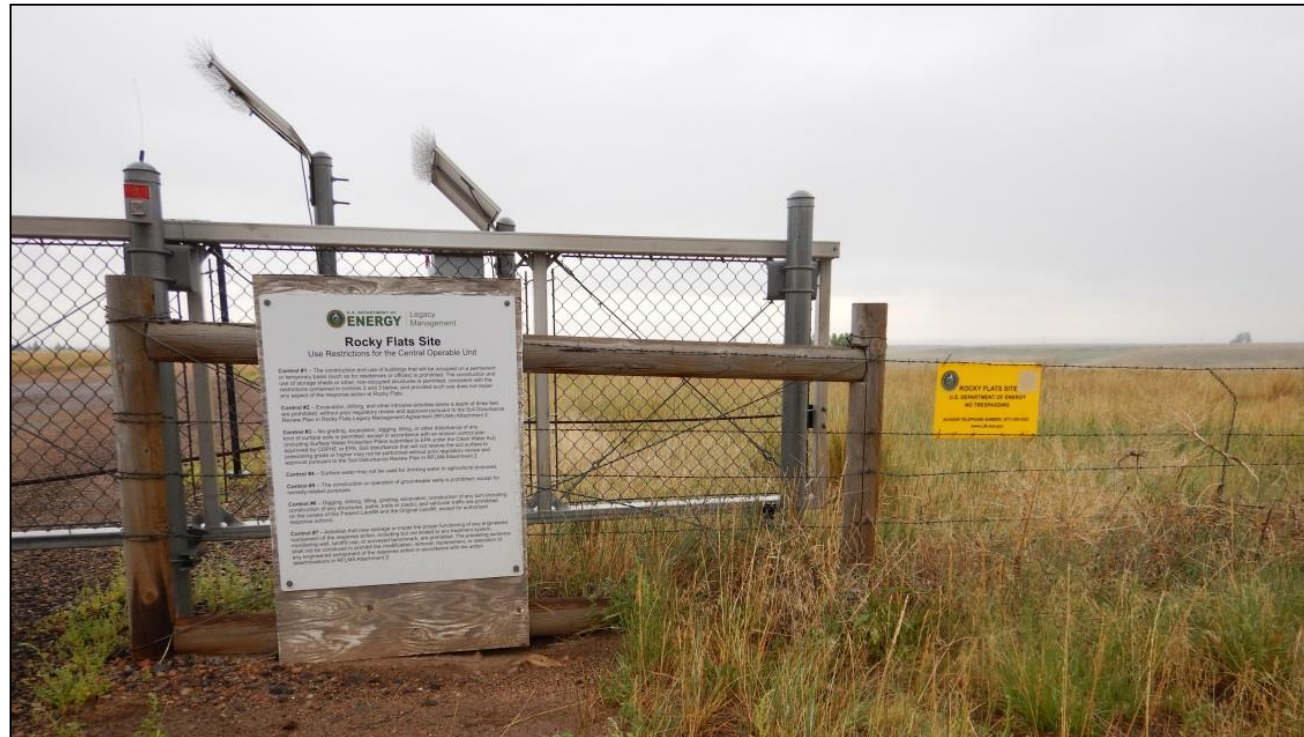
Quarterly Sign Inspections

- RFLMA physical control
- Signs inspected on March 18, 2020
 - All signs in good condition and legible
 - Some DOE stickers replaced due to weathering
